Drainage Report for
Structure E-15-AH
SH 170 OVER SOUTH BOULDER CREEK

Prepared for:
Colorado Department of Transportation

Prepared by:
Hydrau-Tech, Inc.

May 2013

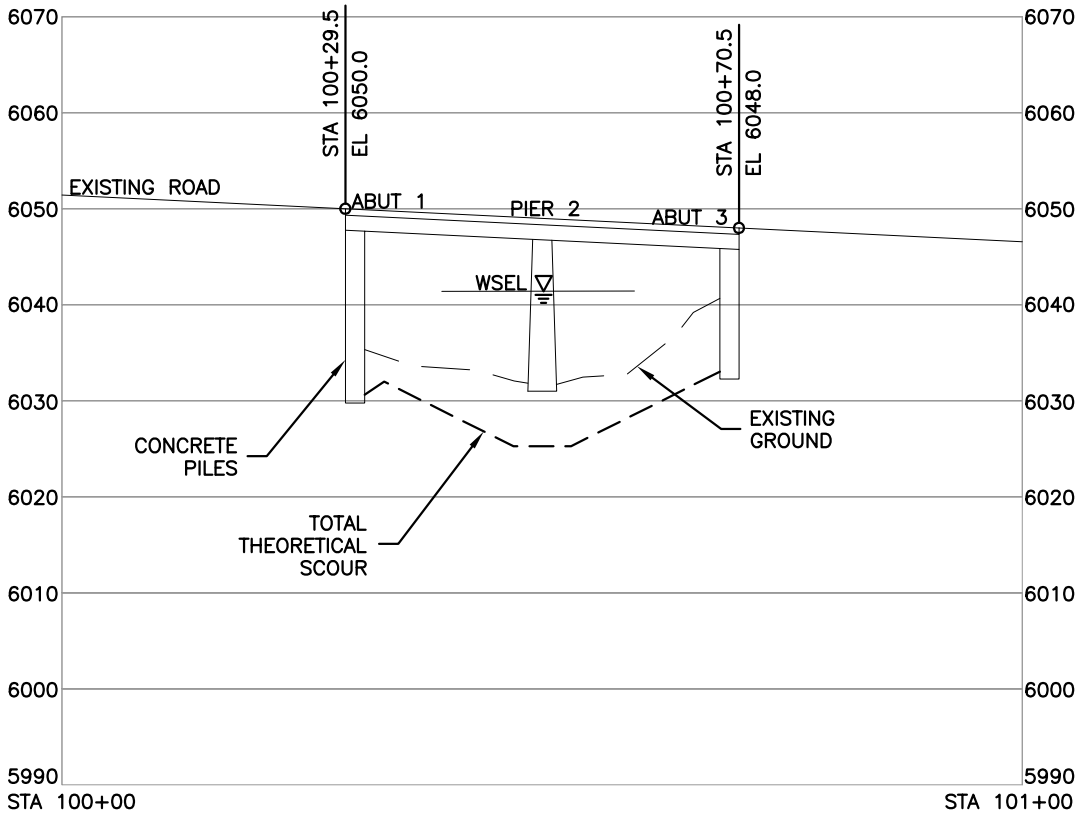
FIGURE
6

The results of the scour analysis for the 500-year event are summarized in Table 7. Figure 6 presents the theoretical scour depths from a profile view of the bridge. Detailed scour calculations are located in Appendix G.

Scour Component	Long Term Degradation	Contraction			Pier Scour	Abutment Scour	
		Left Overbank	Main Channel	Right Overbank	2	Left	Right
	0.0	0.0	0.0	0.0	6.5	4.7	2.0
Total Scour (ft)					6.5	4.7	2.0

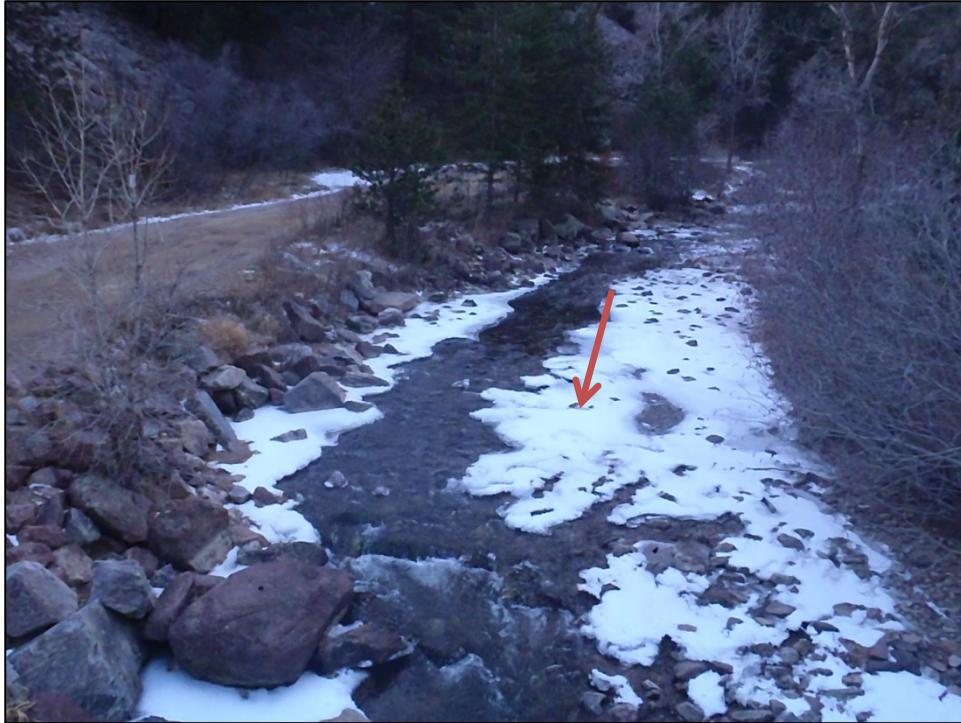
1. The theoretical scour from the 500-year event is above the estimated footing depths.
2. The abutments have sufficient sized riprap protection to prevent abutment scour as shown in Figure A7 and A8.
3. The channel bed is comprised of cobbles and boulders and will help protect the channel bed and abutments during high flow events as shown in Figure A3.

Figure A.3.
Looking toward South Boulder Creek upstream from the structure

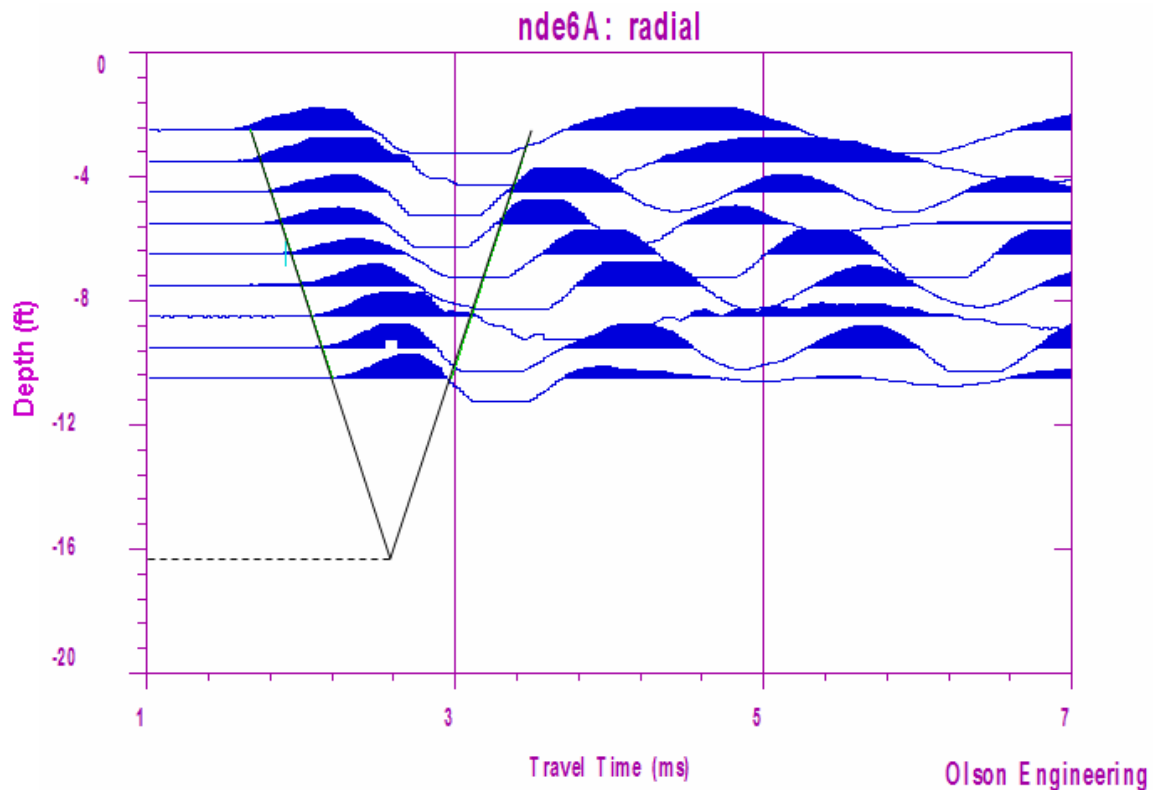
Figure 2 – US data collected from Boulder county bridge number E-15-AH, West foundation wall. Apparent length is approximately 16 ½ feet.

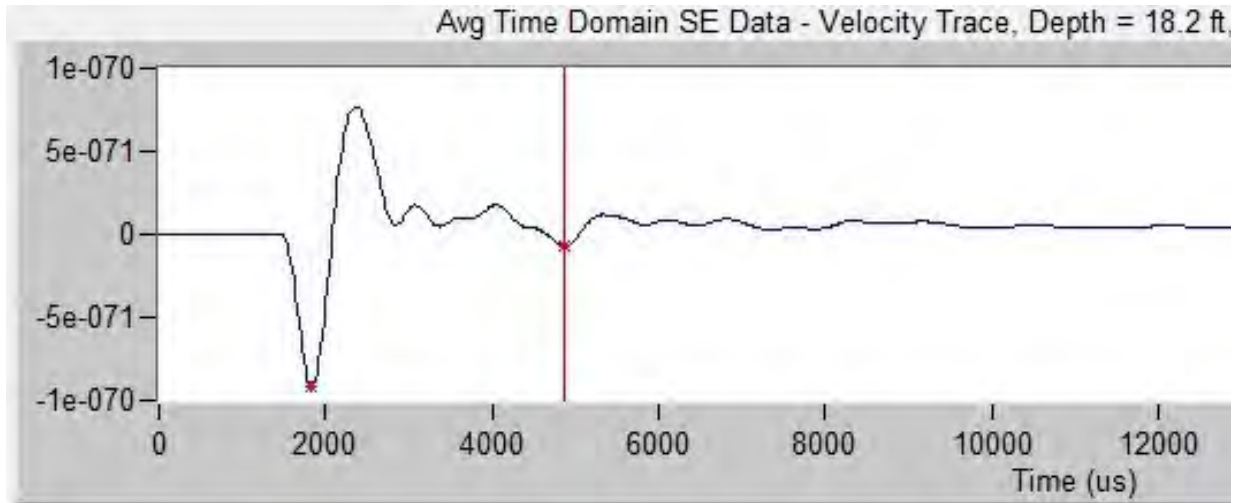
The Sonic Echo (SE/IR) test results indicated the pile lengths, referenced from the top of the foundation wall, to be 18.2 feet for the West foundation wall and 13.7 feet for the East foundation wall. The SE plots from the SE/IR test results for these foundation walls are presented below in Figures 3 and 4. The SE/IR plots presented in this report are taken from a multitude of SE/IR test records from each pile to show the representative, average measured pile length.

Figure 3 - Sonic Echo data collected from Boulder county bridge number E-15-AH, second West foundation wall test. Apparent length = 18.2 feet (from top of foundation wall).

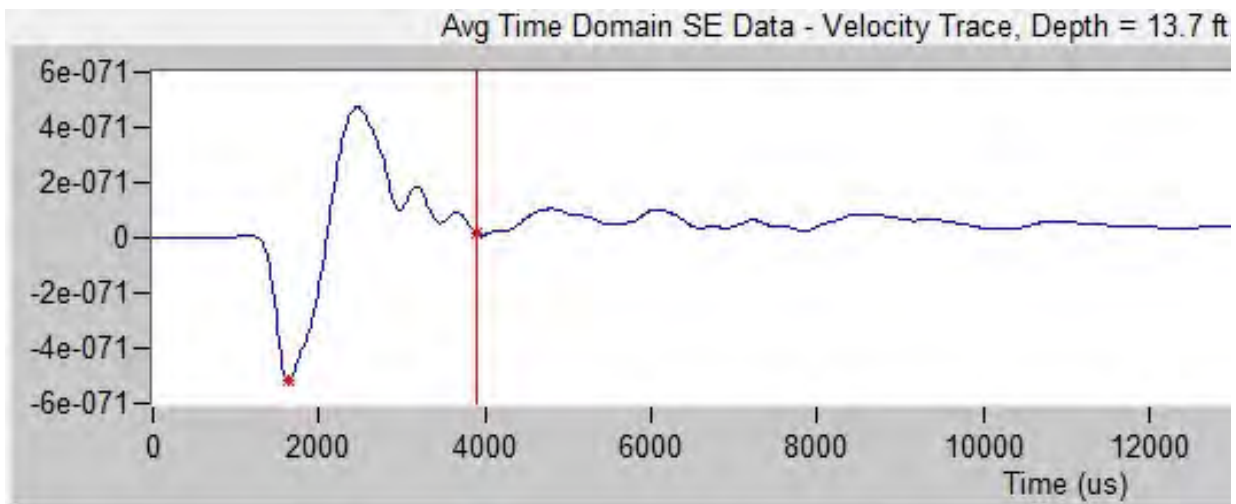
Figure 4 - Sonic Echo data collected from Boulder county bridge number E-15-AH, second East foundation wall test. Apparent length = 13.7 feet (from top of foundation wall).

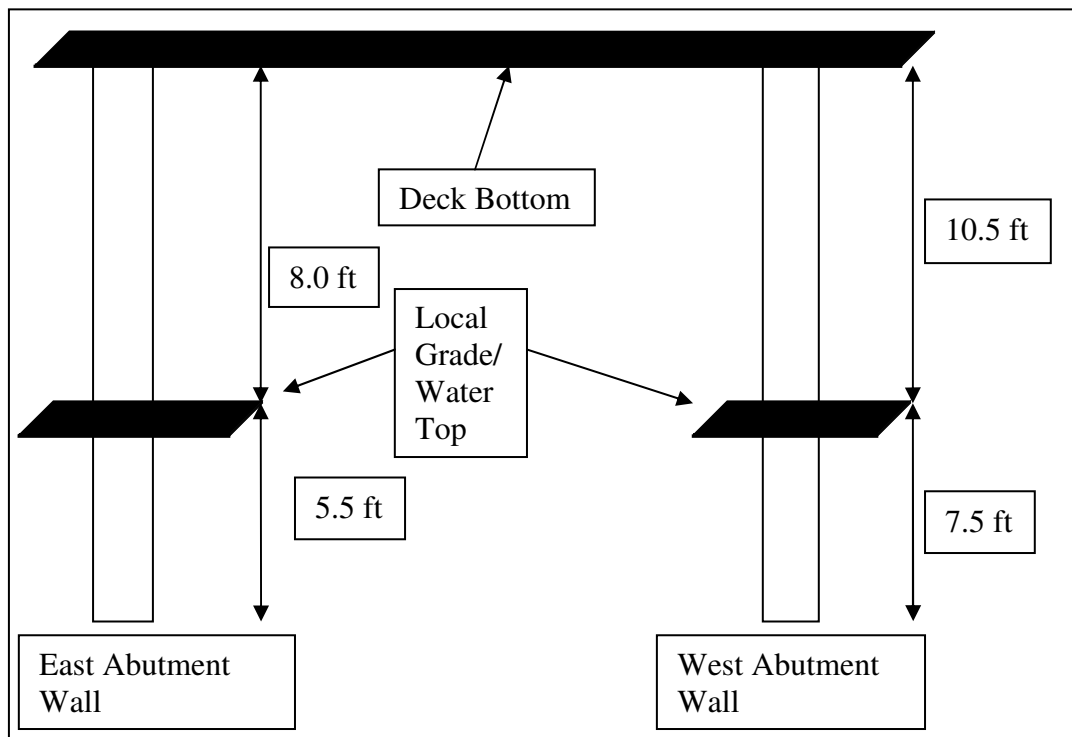
Figure 5 Sketch of Foundation Elements

An approximate foundation wall total height of 18 feet was measured for the West foundation wall and an approximate foundation wall height of 13 ½ feet was measured for the East foundation wall at Boulder county bridge E-15-AH. The West foundation wall height was determined by comparing the SE/IR data with the US results. The US results concluded to be less accurate than the SE/IR data due to in-situ field conditions and overall data quality. Thus only SE/IR data were collected for the East foundation wall. During data acquisition, the West foundation wall had approximately 10 ½ feet of exposed wall above grade/stream level and the East foundation wall had approximately 8 feet of exposed wall. Based on these data the West foundation wall extended 7 ½ feet into the ground and the East foundation wall extended 5 ½ feet into the ground at the time of acquisition.

A sketch of the bridge components as observed at the time of testing as well as measured with the NDE investigation is presented below in Fig. 5. As seen, the sketch includes the measured height of the abutment walls above local grade and below the bridge deck, as well as the measured depth of penetration into the subgrade of the foundation walls.

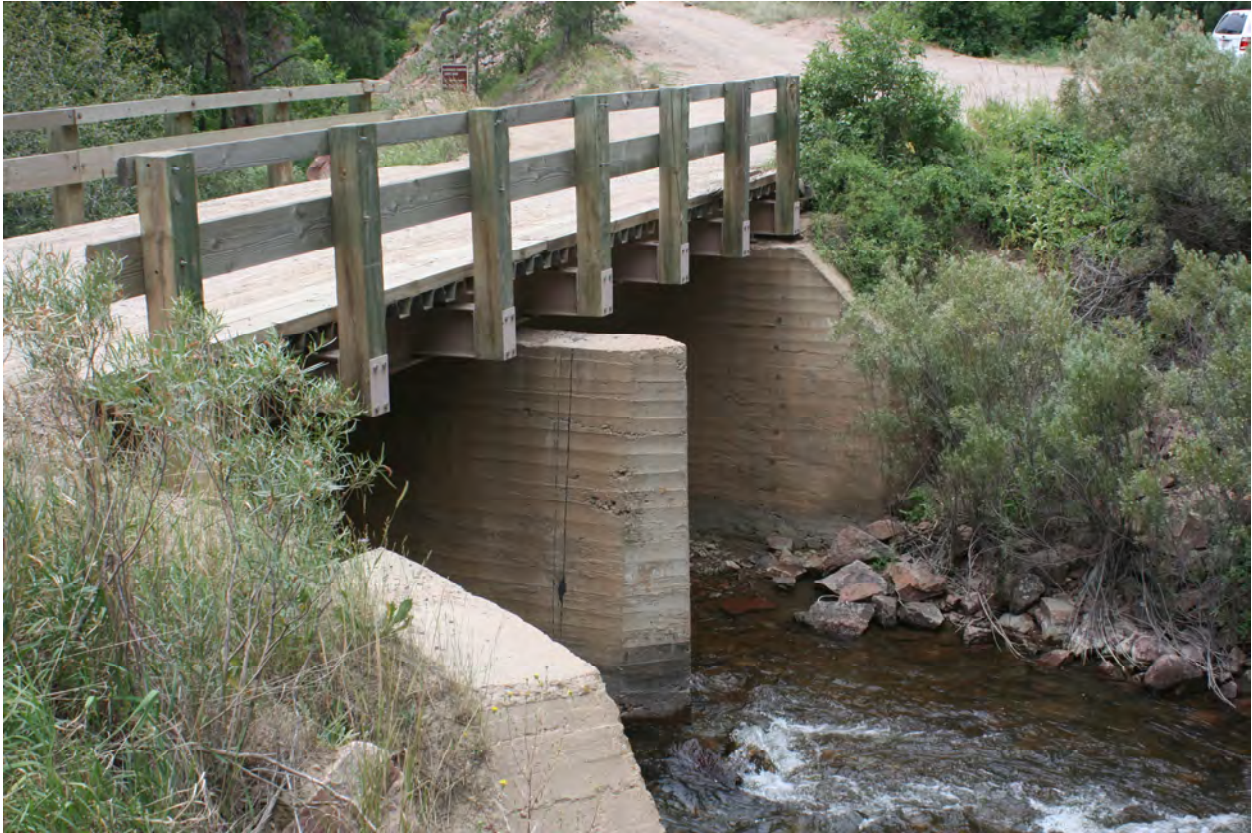
Figure 6 View to West Abutment Wall (Note – visible center pier is abandoned and is not part of the active structure)

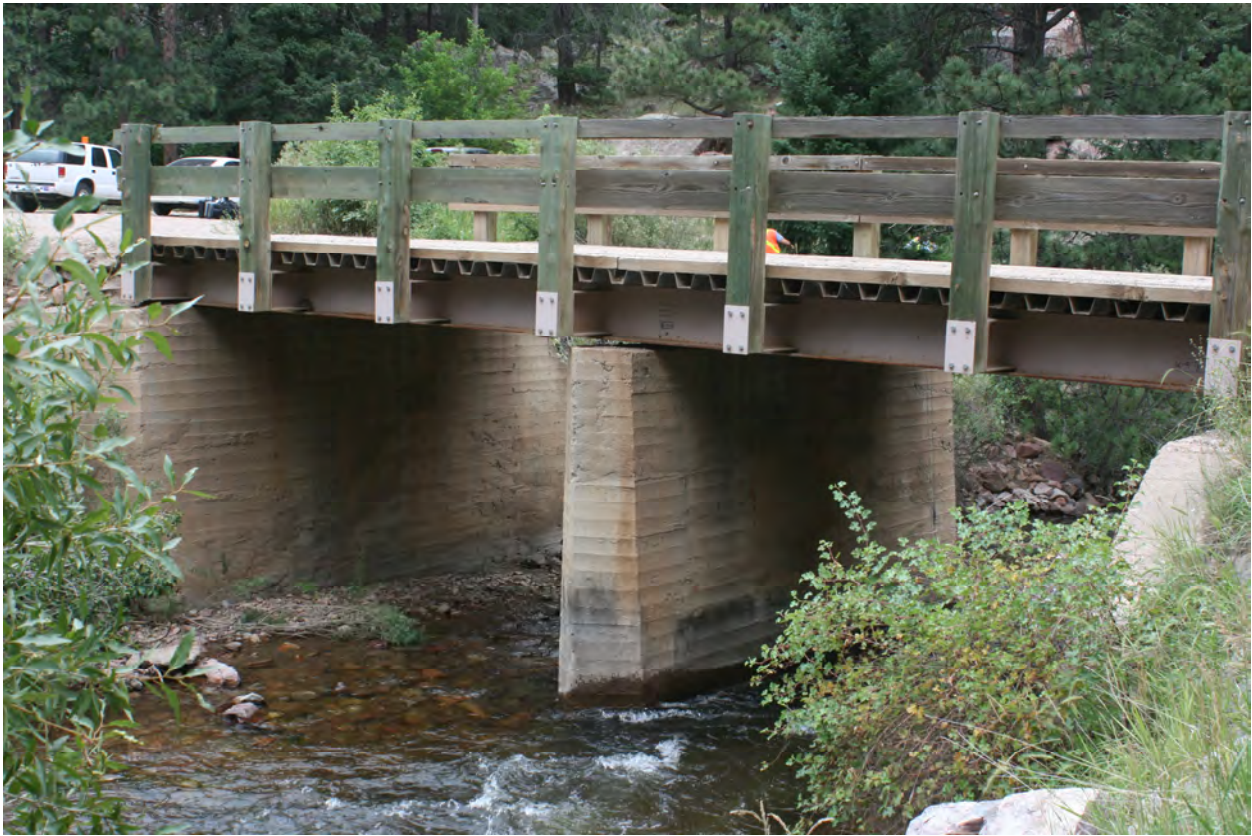
Figure 7 View to East Abutment Wall (Note – visible center pier is abandoned and is not part of the active structure)
